Mind Your T's and Z's: Discovery and Correction of Dual Energy X-ray Absorptiometry Cross-Calibration Bias

Samuel J Fahrenholtz, PhD¹; Jeremiah Long, MD¹; Khushnood Hamdani, MS¹; Michael G Fox, MD, MBA¹; Michael Whitaker, MD²; Jennifer Palmieri, RT(R)(M)¹; William F Sensakovic, PhD¹

1- Department of Radiology, Mayo Clinic Arizona

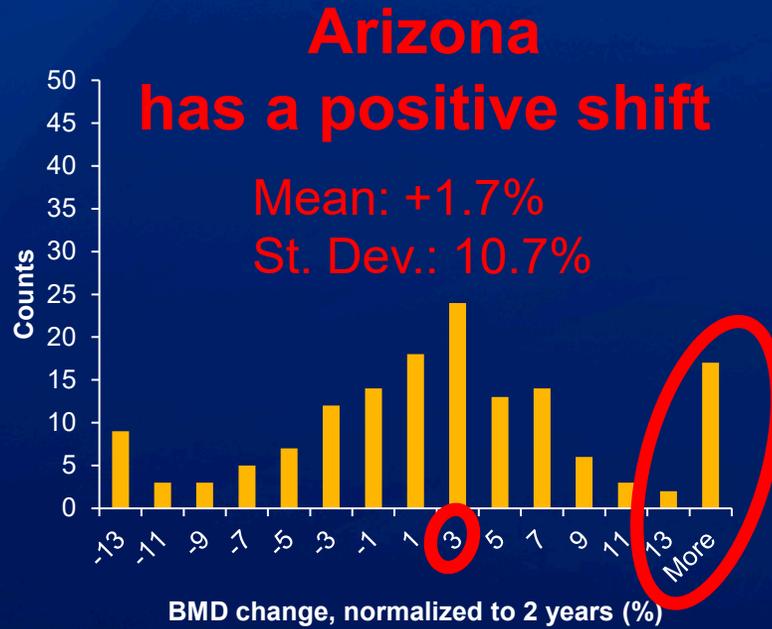
Clinical suspicion confirmed: Arizona had much higher BMD gains

Significant
 $p = 0.00583$

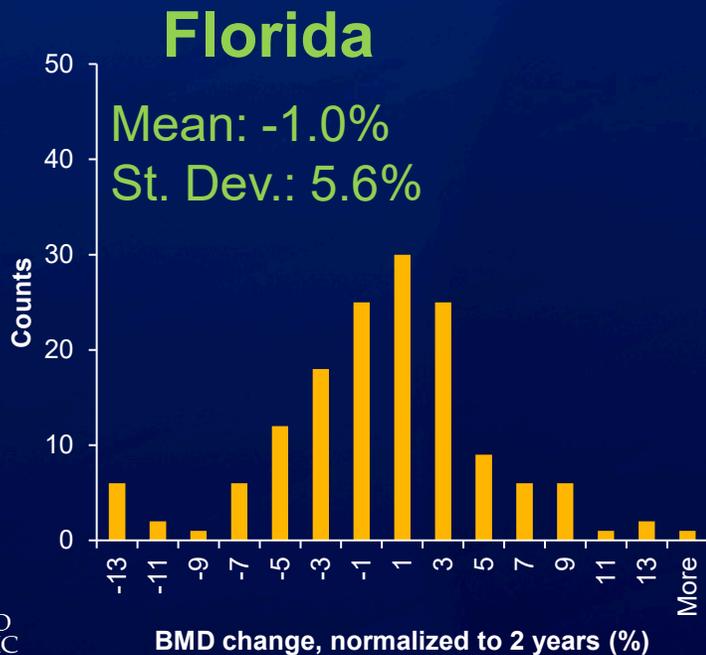
Significant
 $p = 0.00320$

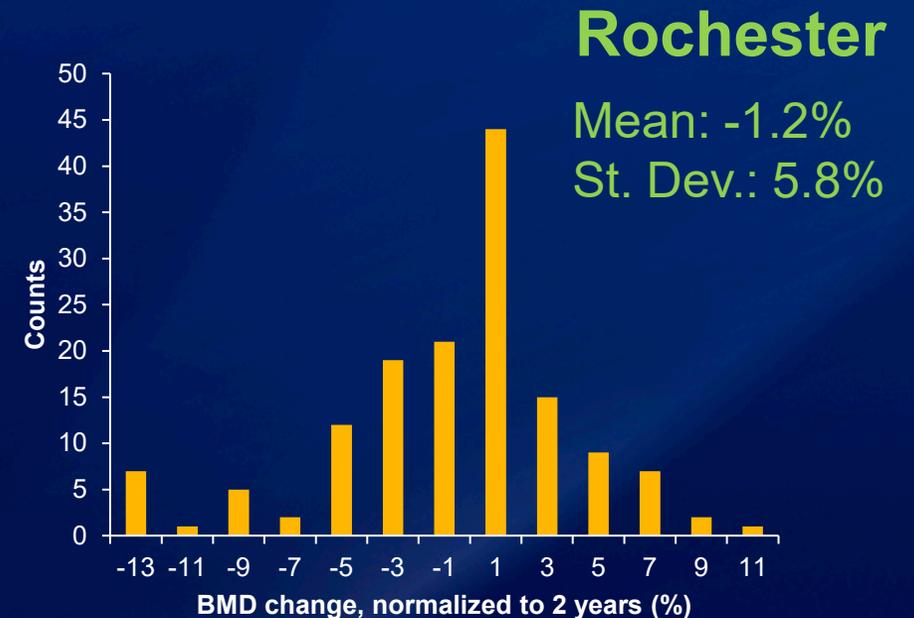
$p = 0.746$
Not Significant

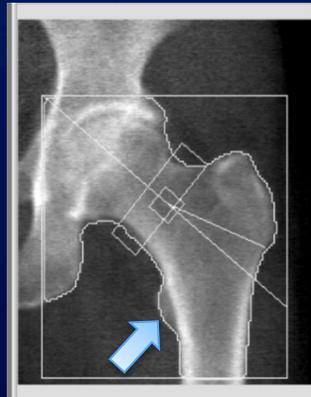
Lesser Trochanter

- Spine: Should be straight vertical and not too high or too low. [2]
- Hip: Should not crop the femoral head nor reveal the lesser trochanter. [2]
- Similar errors found at all three Mayo Clinic sites.
- Suboptimal positioning is frequently the result of patient flexibility limitations.
 - Techs repeat bad positioning from earlier measurements to ensure consistency.

Result 2: Poor positioning likely not the cause

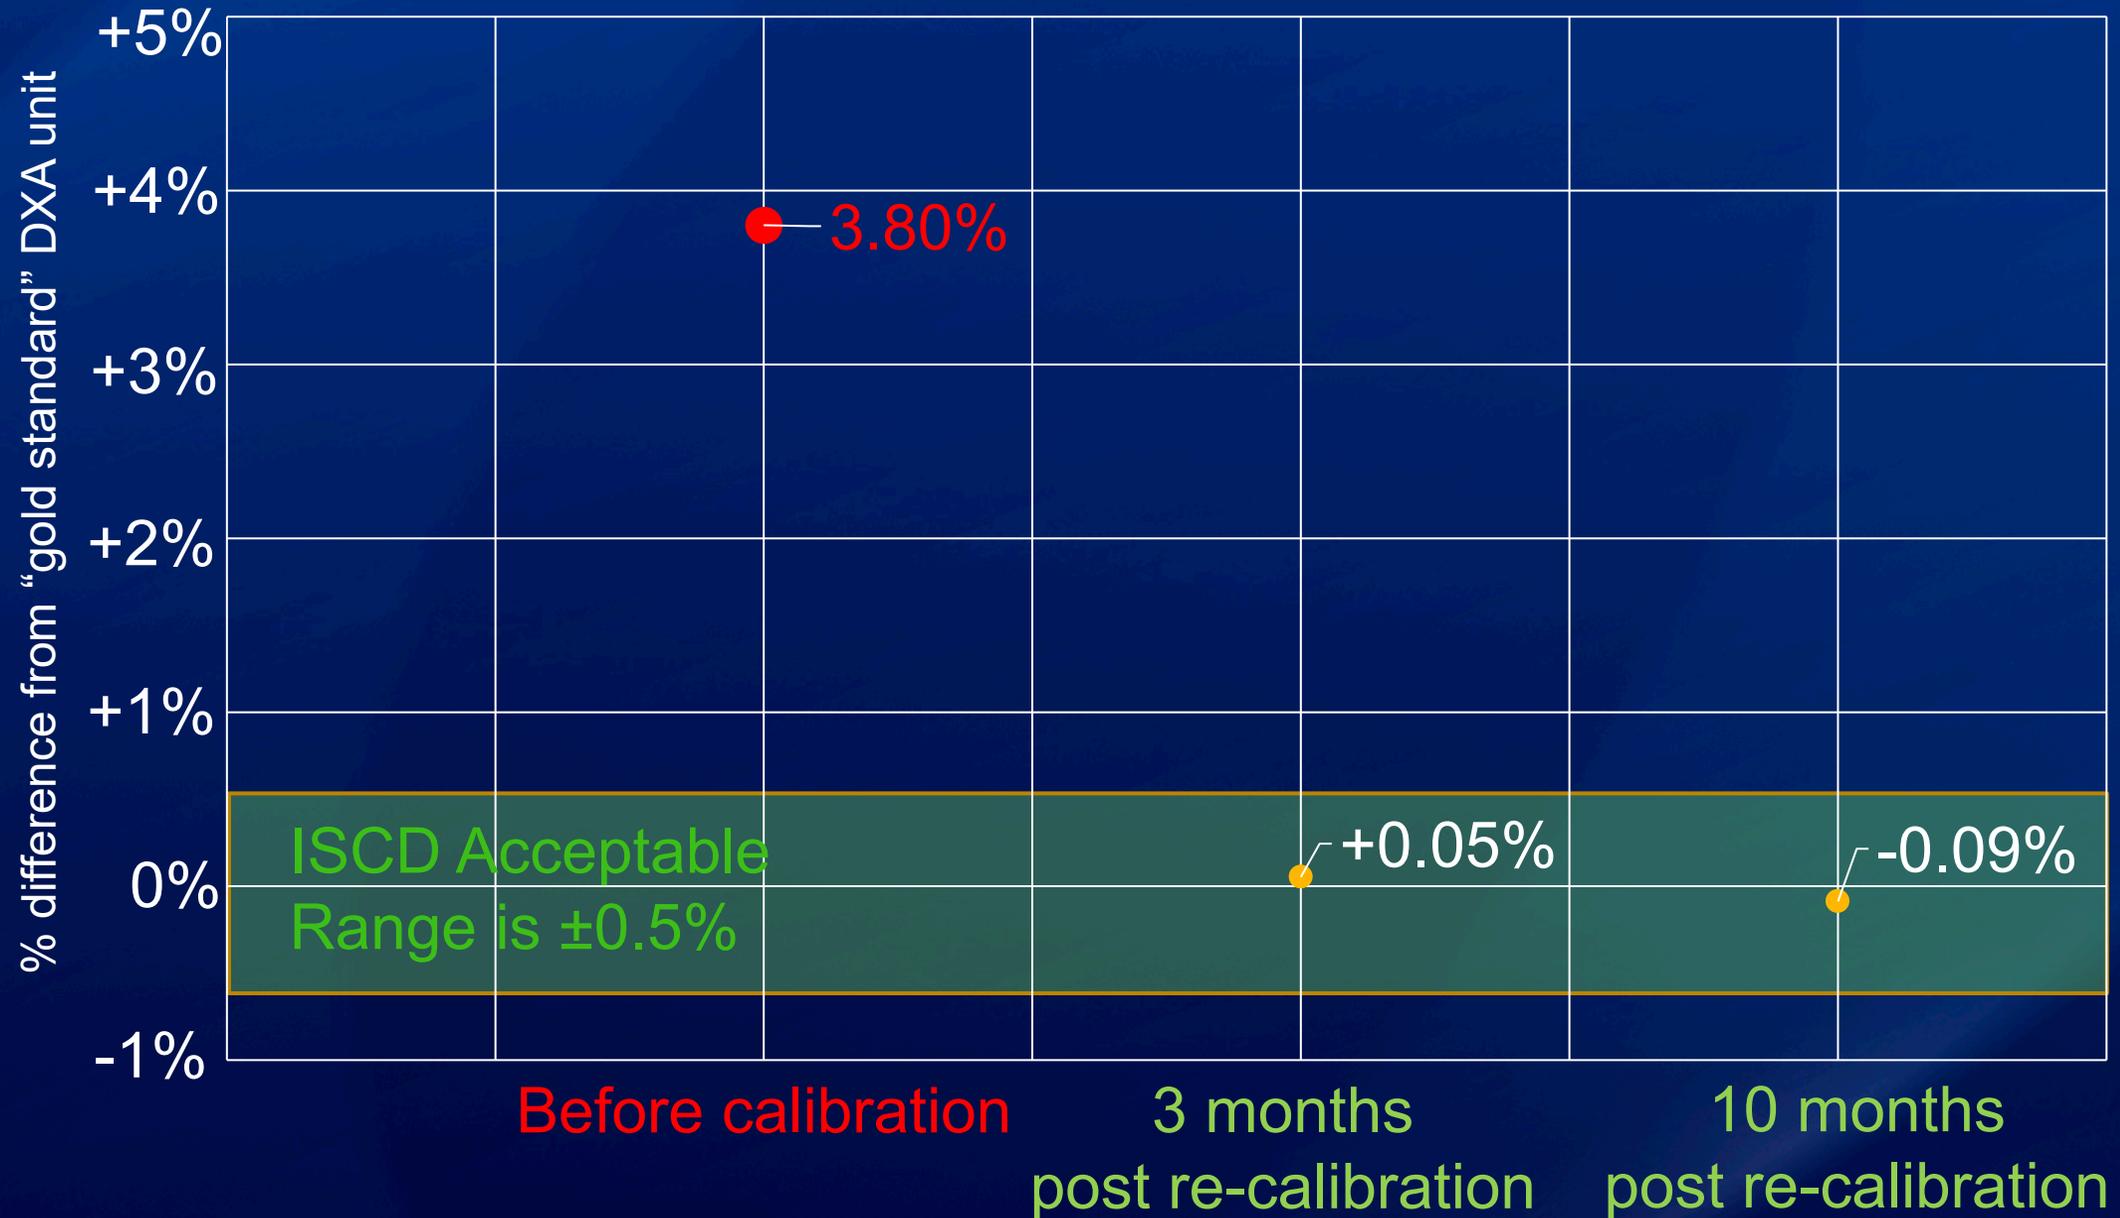
Initial and follow-up measurements of cross-calibration

- Vendor found no maintenance issues and reported machines were cross-calibrated at installation.
- ISCD guidelines recommend $< 0.5\%$ BMD difference using the same vendor daily QC phantom on both machines over 20 consecutive days [1].
 - Physical distance prevented us from the phantom every day, so the QC phantom was measured 10 times on each unit instead.
- One DXA reported BMD that was 3.8% higher than the other.
- A vendor recalibration nearly eliminated the difference.
 - We chose one unit as the “gold standard” for all future units to be calibrated to.
 - Follow-up cross-calibration measurements confirmed a durable improvement.

Result 3: Cross-calibration was the cause & recalibration solved it

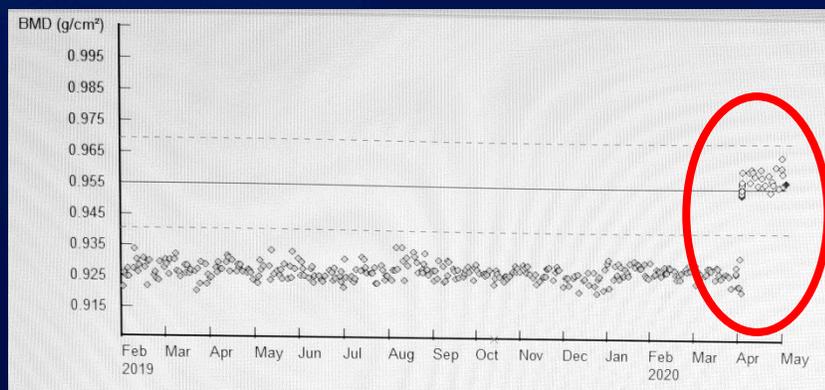
Recalibration impact on BMD measurement

- Setting one machine as the new gold standard device meant that older scans from the other device were no longer reliable.
 - Physician and Allied Health communication campaign was implemented to ignore those old measurements.
 - Patients who had baseline measurements from recalibrated scanner received new baseline scans by designating a new 'good' scan for percent change calculations.
- Accepted values for the QC phantom associated with the other scanner were relabeled based on values given by the gold-standard DXA scanner.
- A cross-calibration check became part of our acceptance and annual QC.
